Evaluation of Precast Portland Cement Concrete Panels for Airfield Pavement Repairs

Lucy P. Priddy

May 2015

Final report

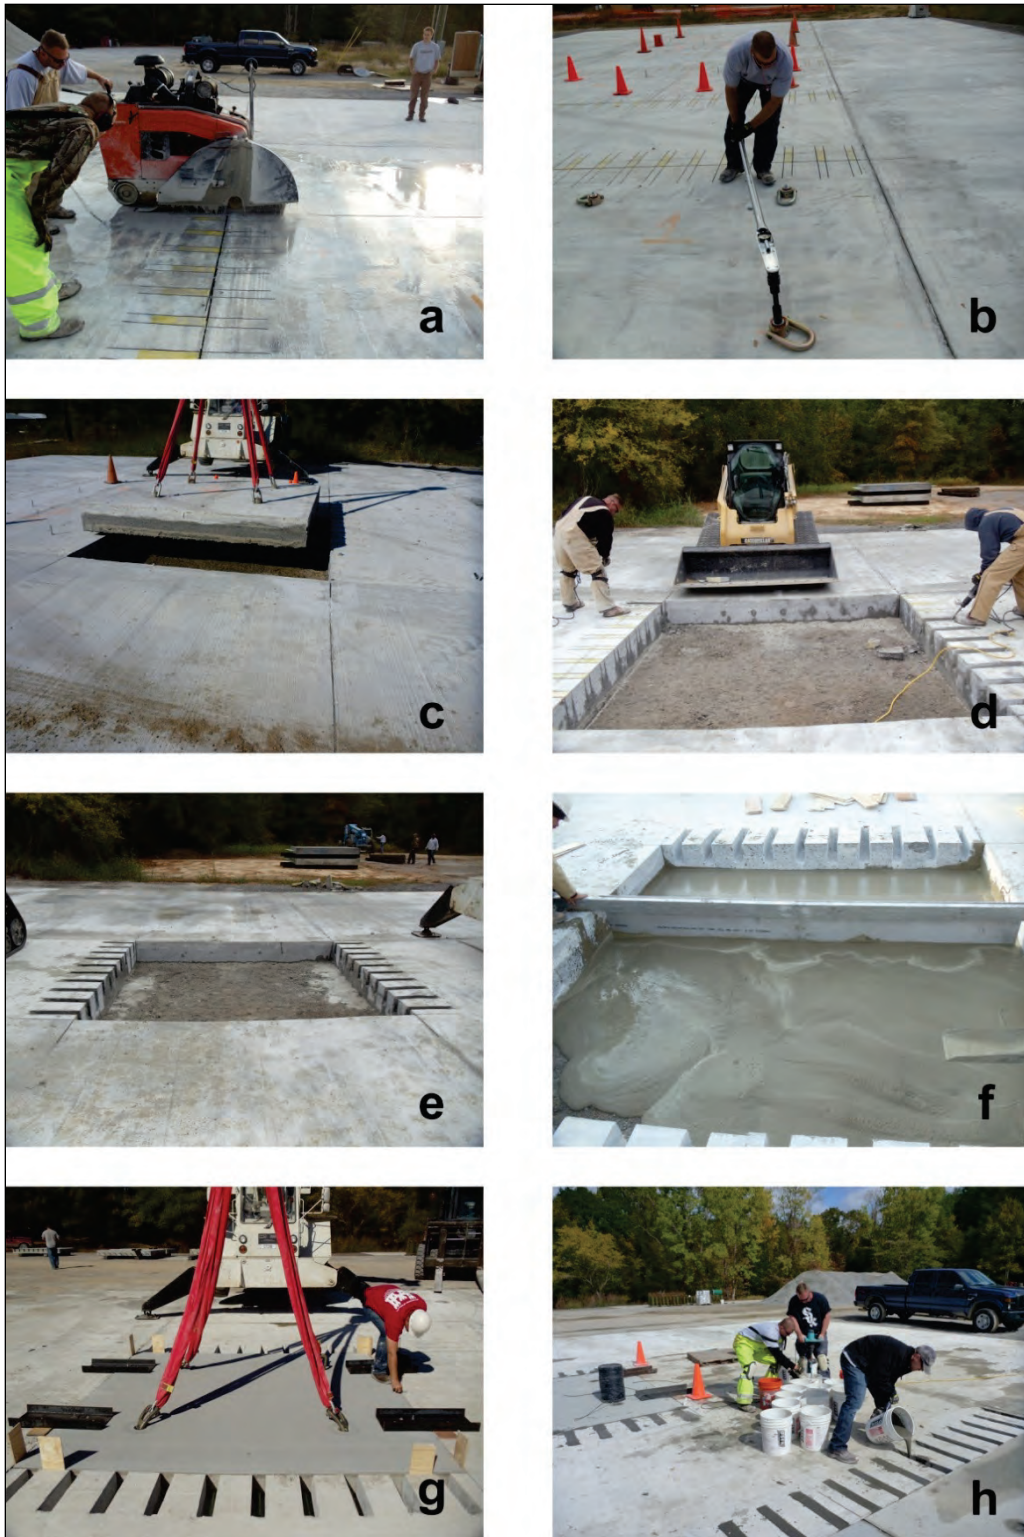
Figure 3.3. (a) Saw cutting perimeter, (b) installing lifting eyes, (c) lifting pavement, (d) preparing dowel slots, (e) prepared repair area, (f) screeding flowable fill, (g) lowering panel with bridge plates, and (h) sealing dowel slots.

The general repair process is shown in Figure 3.3. The three repair areas were prepared by first marking the repair area boundaries. Following marking, saw cutting of the perimeter of the repair and dowel slots was conducted using a walk-behind concrete floor saw. A series of progressively larger blades was utilized to saw cut the pavement full depth. For this investigation, in lieu of breaking the pavement out and excavating the designated repair area, the saw-cut PCC to be replaced was lifted using commercially available concrete expansion anchors installed in accordance with manufacturer-recommended instructions. The expansion anchors were attached to commercial rigging equipment sized for the lifts, and the cut slab pieces were removed using a mobile crane.

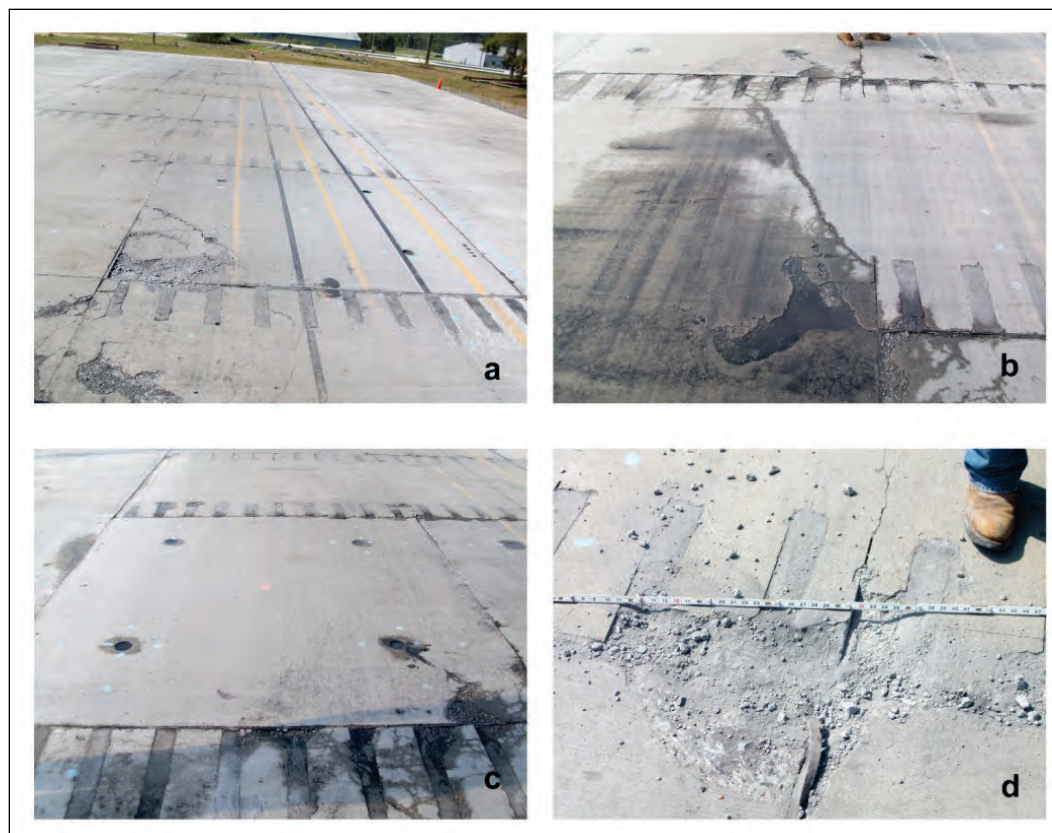
Figure 3.5. Repair failure details: (a) Repair 1, Panel 1: high-severity corner break/spall and shattered parent slab; (b) Repair 2: diagonal cracking in parent slab between Repairs 1 and 2 and cracking and spalling of Panel 2 due to the parent slab deterioration; (c) close-up of the cracking and deterioration in the parent slab and dowel slots and corner of Panel 2; (d) Repair 3, Panels 6 and 7: high-severity spalling in corner of Panels 6, 7, and the parent slabs south of the repair.

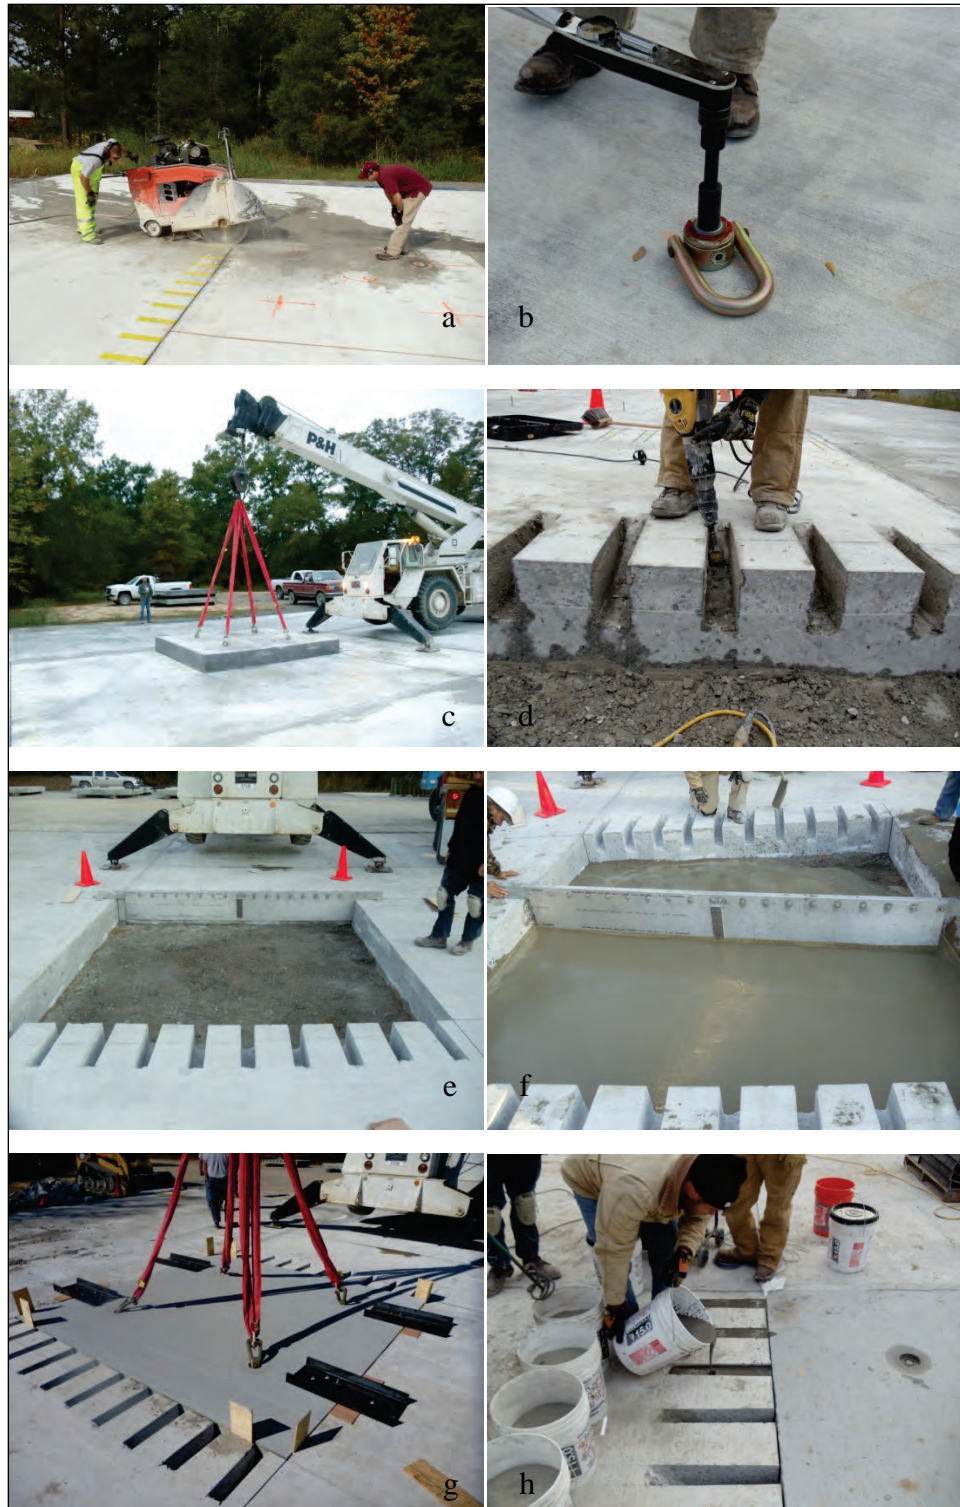
Figure 4.2. Repair procedure: (a) saw cutting the repair area and dowel slots, (b) installing lifting eyes to concrete expansion anchors, (c) removing parent PCC, (d) preparing dowel slots, (e) prepared repair area, (f) screeding flowable fill bedding material, (g) lowering panel into repair area, and (h) sealing dowel slots with rapid-setting grout.

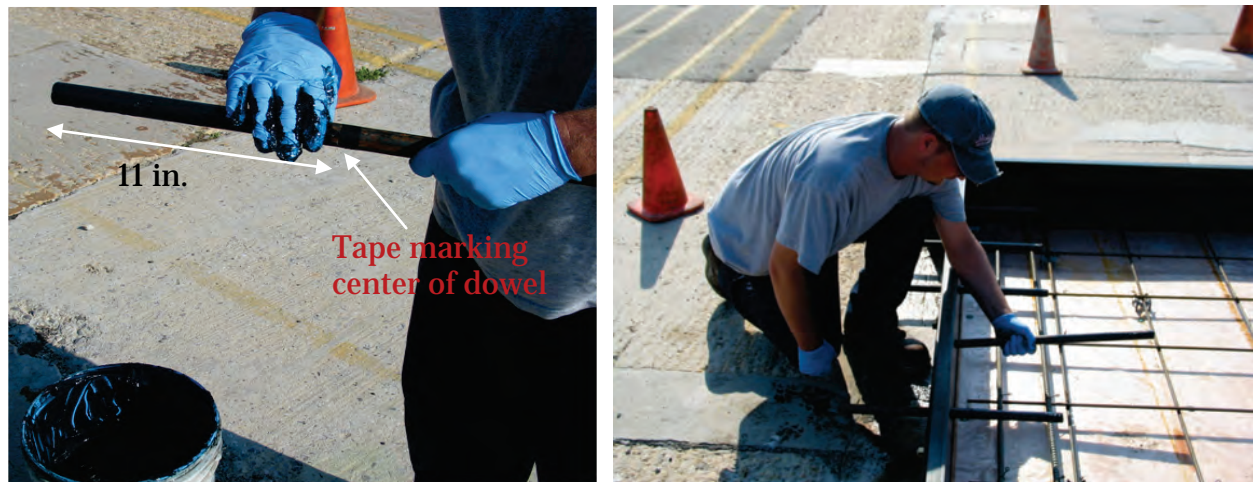
Figure B.10. Installation of the dowel bars.

Ensuring and maintaining proper alignment of each dowel was imperative. Misaligned dowels have the potential to prevent form removal, may possibly result in damage to the precast panel and/or the rigid form, and could negatively impact load transfer and/or cause premature pavement failure. The following paragraph describes the dowel installation process in greater detail.

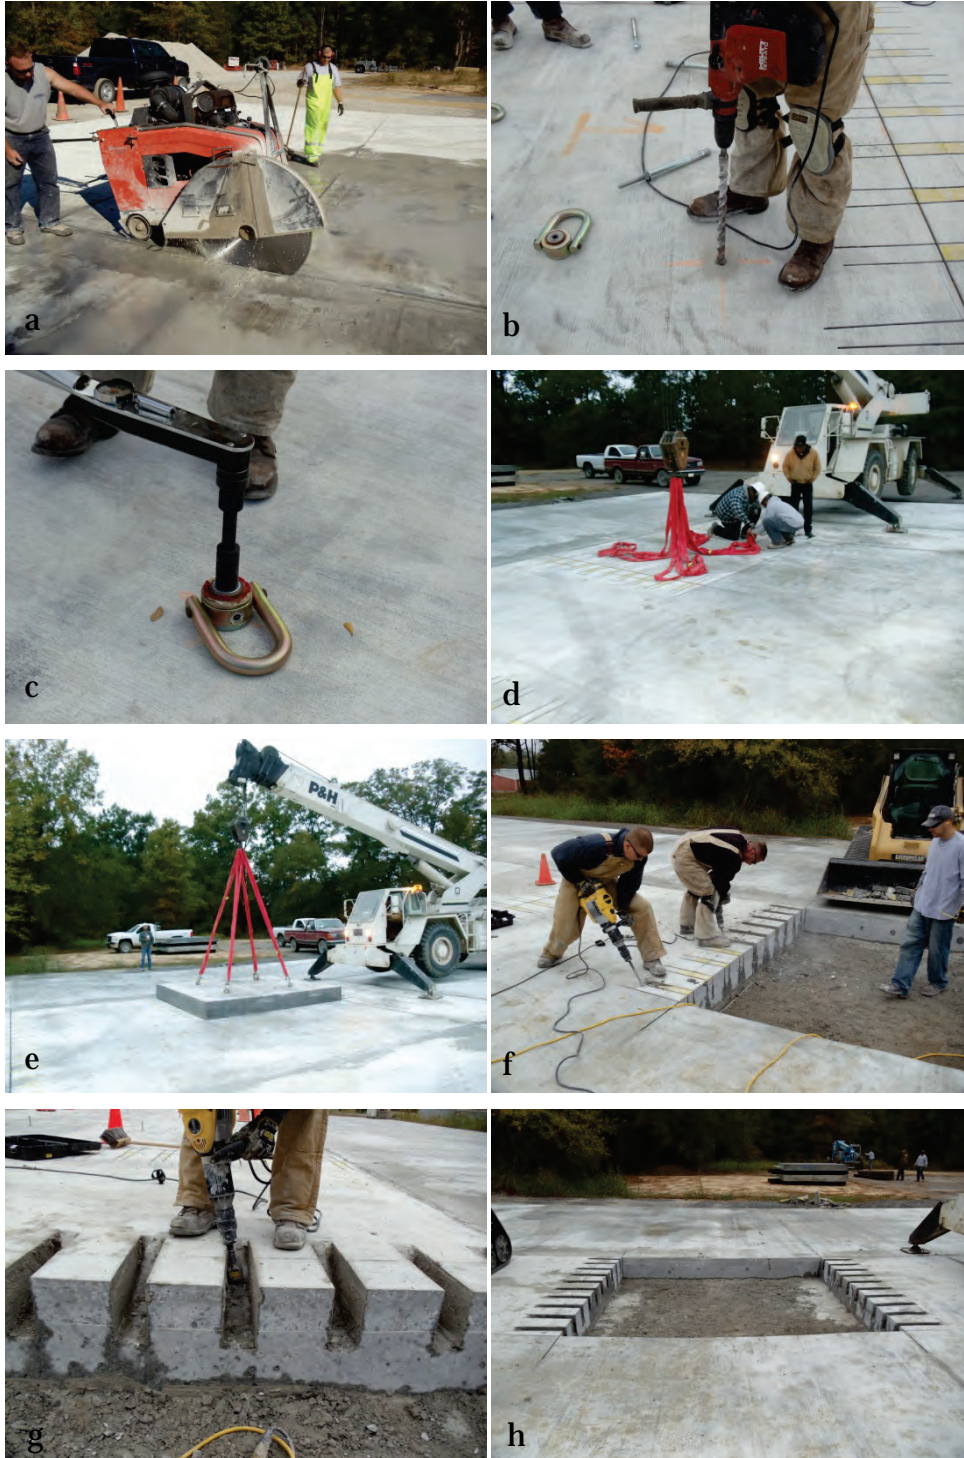
Figure C.4. Preparation and removal of parent PCC: (a) saw cutting dowel receptacles and repair area, (b) drilling to install concrete lifting anchors, (c) installing lifting eyes, (d) connecting lifting eyes to crane rigging, (e) lifting “damaged” pavement, (f) preparing dowel receptacles using jackhammers, (g) close-up of dowel receptacles, and (h) prepared repair area.

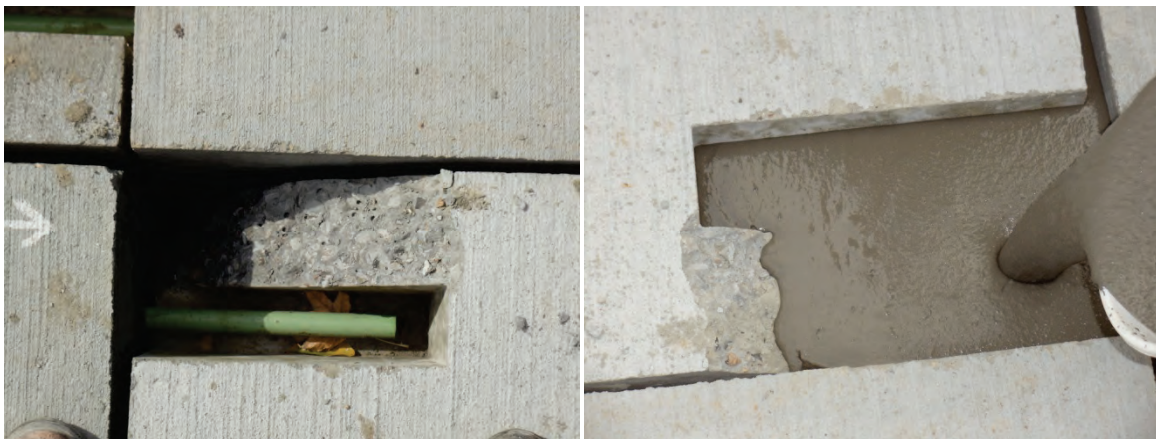
Figure C.11. Left: broken corner of a panel, and right: repair of broken corner.

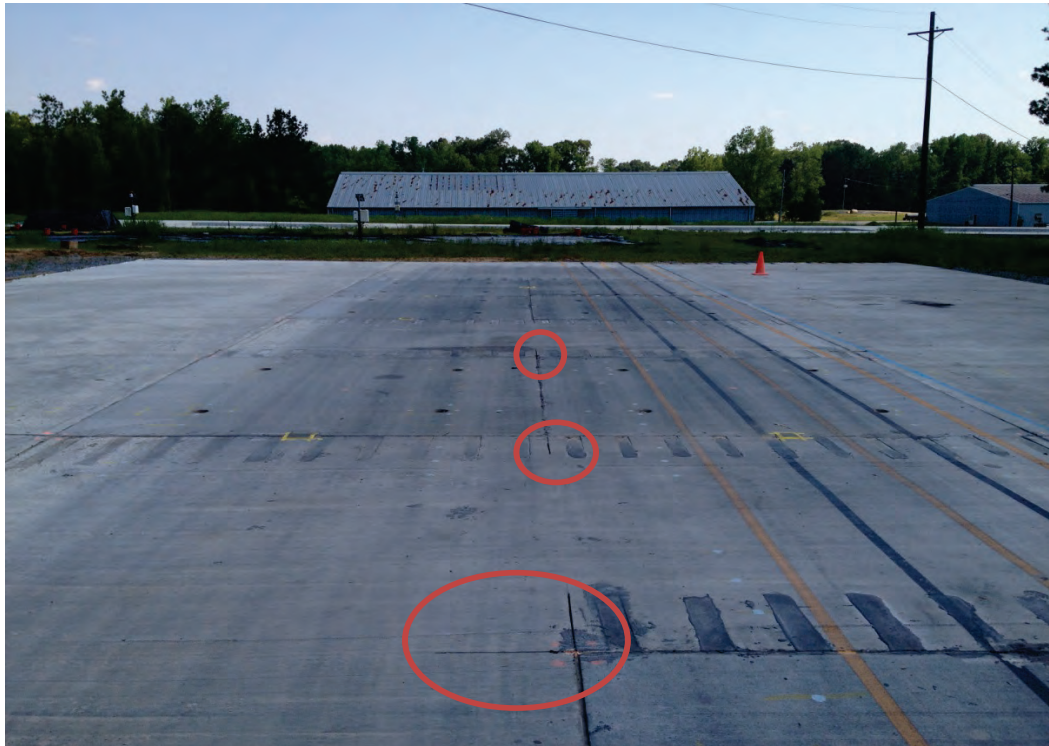
Figure D.5. Saw cuts at corners of panels.

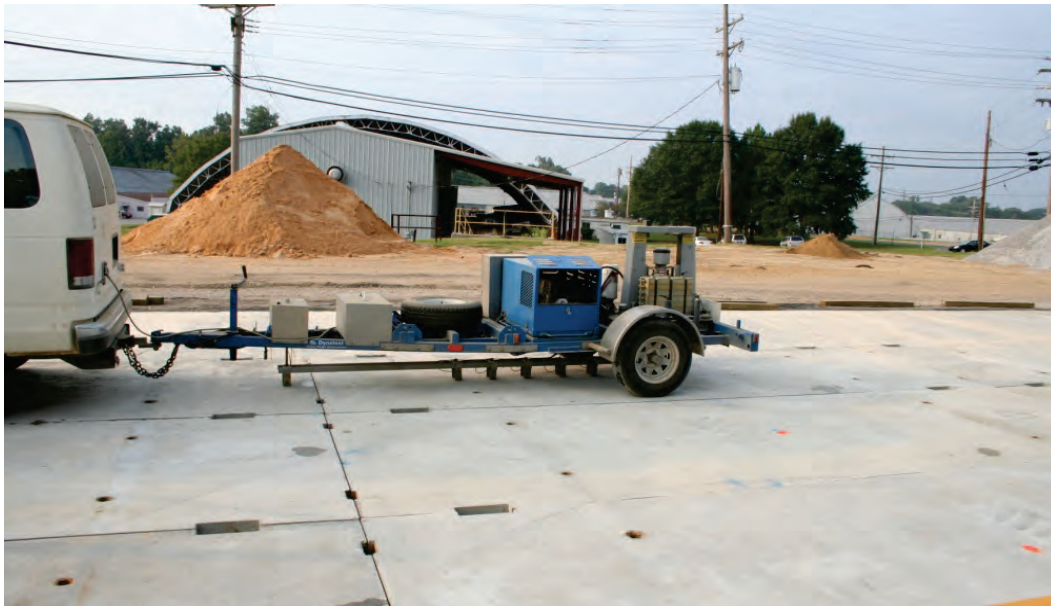
Figure D.9. HWD test device.
